## Case Study

# Steep Slopes Project Profile: Olympic Park, BC

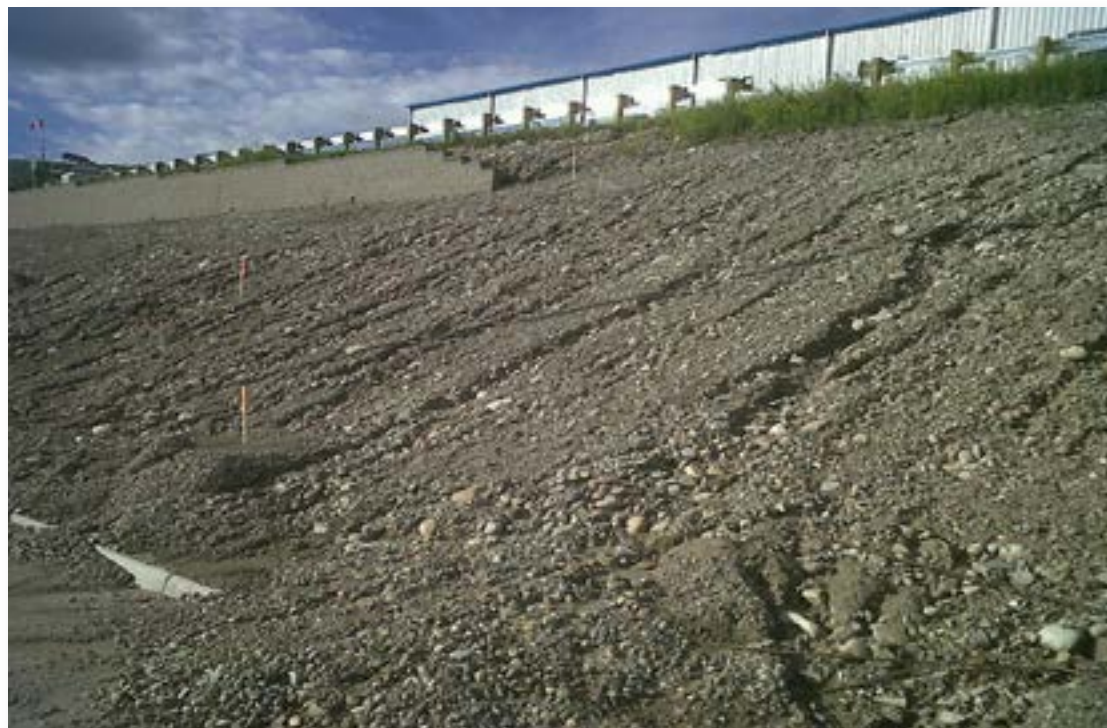
*Steep, highly erodible slopes made the placement of erosion control products difficult, 2011*

The Canada Olympic Park featured steep slopes that were highly erodible due to the extremely sandy slopes. This caused runoff and sediment accumulation on the COP West Parking Lot. Due to the steep, sandy slopes, manually placing soil improvement products and rolled erosion control products proved difficult. Poor soil fertility coupled with the erodible soils made achieving successful vegetation densities difficult.

Verdyol Biotic Earth was applied at a rate of 3900 kg/ha. Separate tackifying agents were not required as the erosion control used on the site was a Bonded Fiber Matrix that includes tackifying agents.

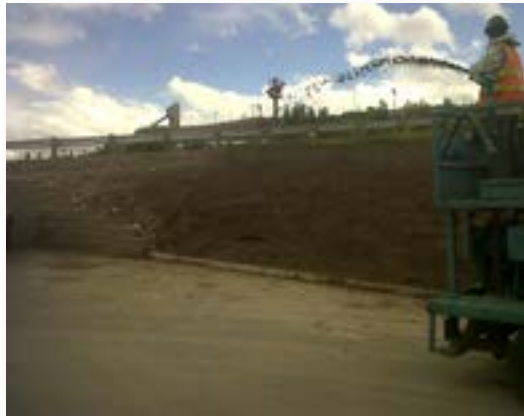
*Biotic Earth is applied hydraulically, 2011.*

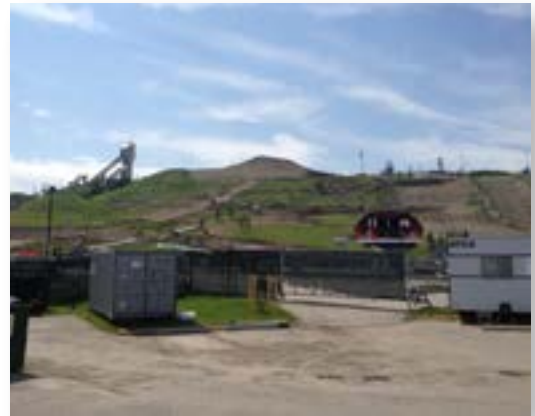
*Growth onsite, 2012.*

One year later, grass establishment on the 2:1 slopes was thick and robust, and some turf varieties were spiking seed bearing heads. Slope erosion and sedimentation onto the COP West Parking Lot was eradicated, and posed no further maintenance issues. Only one application was required, and vegetation remains full on the slopes to this day.

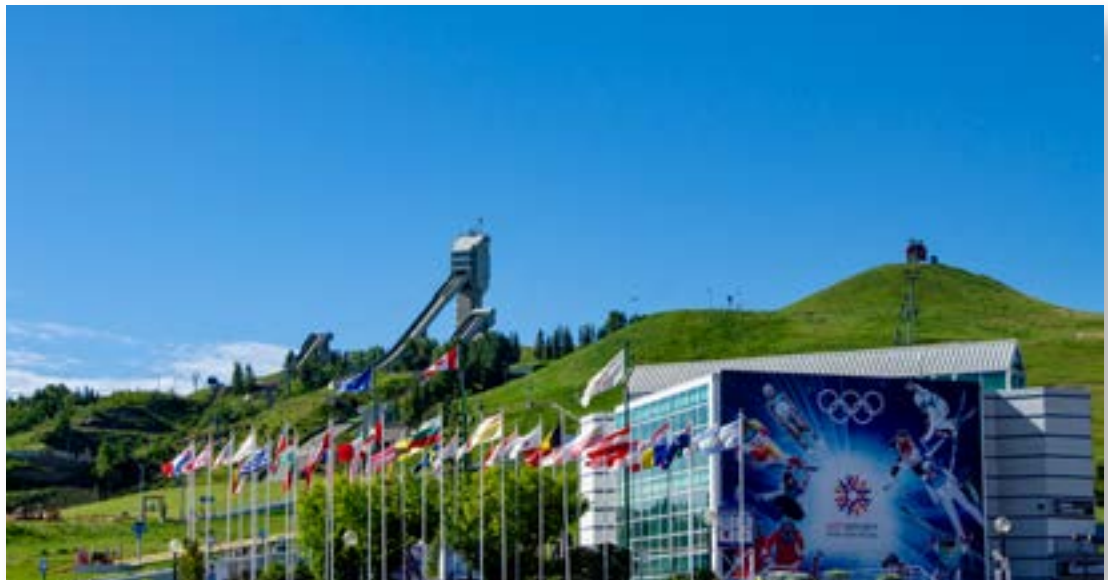
*July 2020. The site is flourishing.*
